FLOOD PLAIN INFORMATION

DELHI, NEW YORK

WEST BRANCH DELAWARE RIVER AND
LITTLE DELAWARE RIVER

THIS REPORT WAS PREPARED FOR UPPER DELAWARE RIVER REGIONAL
WATER RESOURCES PLANNING BOARD BY U.S. ARMY CORPS OF
ENGINEERS, PHILADELPHIA DISTRICT

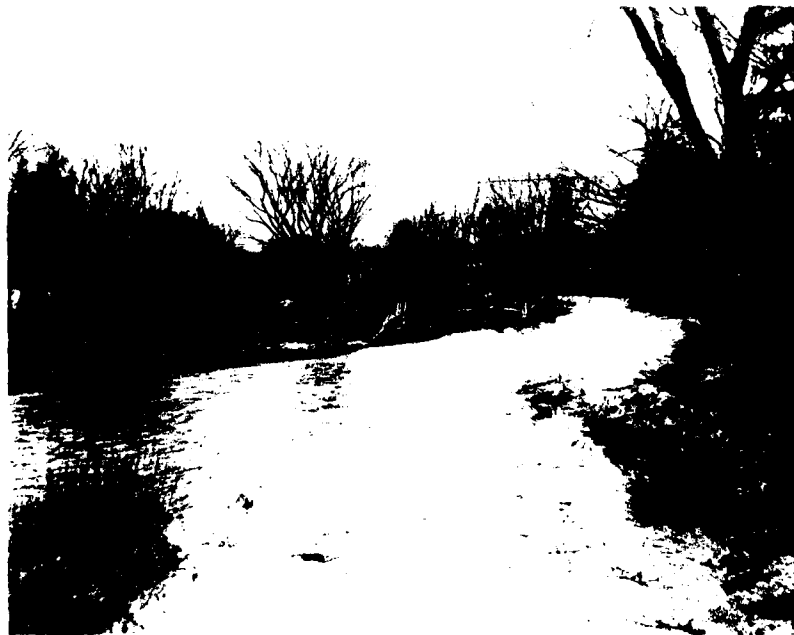
FIGURE 2 - Vegetation along the river banks can become an obstruction to floodflows.

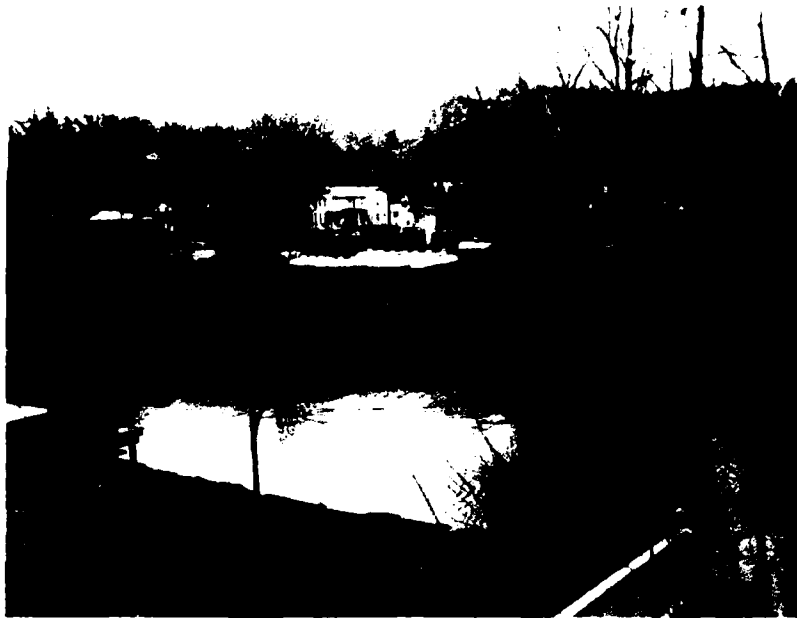
FIGURE 3 - Tanks stored on the island upstream of the Kingston Street Bridge can become floatable and create a hazard downstream.

Material storage on the flood plain — In the Town of Delhi there is very little floatable material stored on the flood plain. However, in the Village of Delhi, there are storage tanks, containers, lumber, cars and domestic equipment which may be unrestrained and buoyant. During time of floods, these floatable materials may be carried away by floodflows causing serious damage to structures downstream and could clog bridge openings creating more hazardous flooding problems. Figures 3 and 4 show materials that are stored on the flood plain.

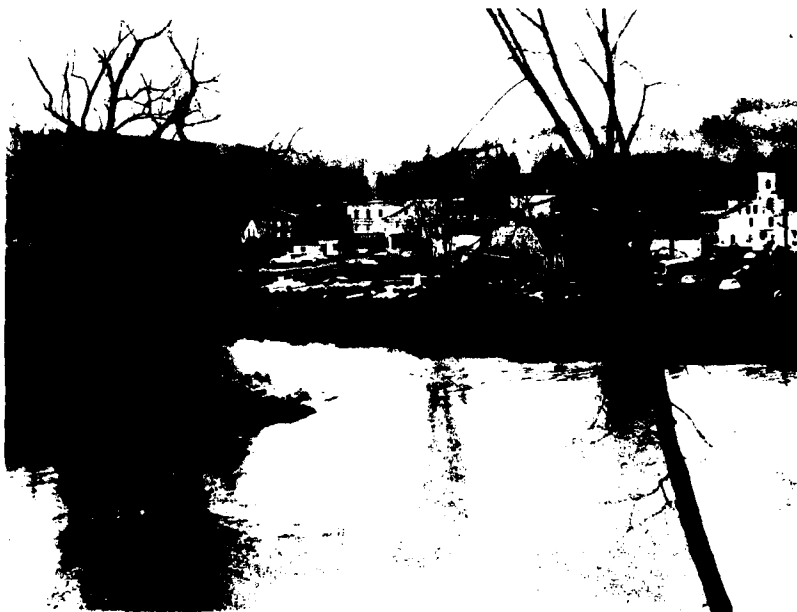
FIGURE 4 - Miscellaneous floatable material stored on the flood plain can increase flood hazards during time of flooding.

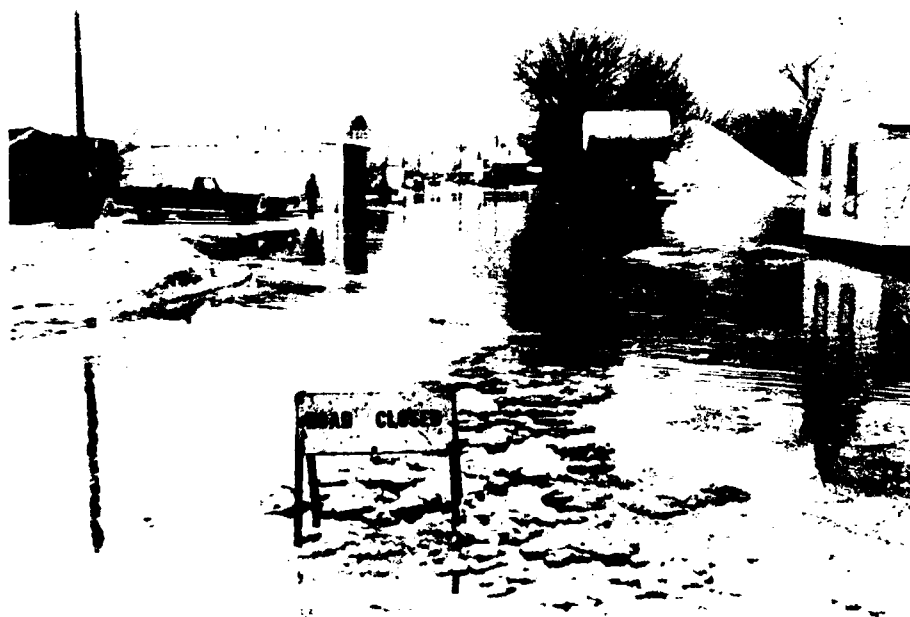
FIGURE 6 - Page Street closed to allow passage of floodwaters and ice during the flood of December 1973.

December 27, 1973 - Warming temperatures and torrential rains with about 12 inches of snow on the ground caused widespread flooding in and around Delhi, New York. Photographs of this flooding can be seen in Figures 5, 6 and 7.

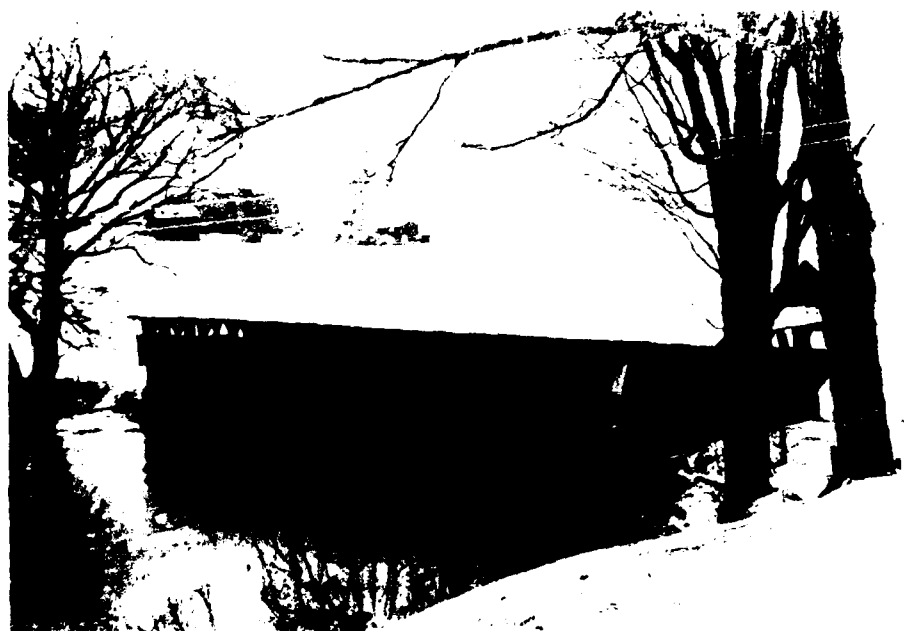
FIGURE 7 - Top photograph is Fitches Bridge as it normally appears.
Bottom view is Fitches Bridge during the flood of December 1973.

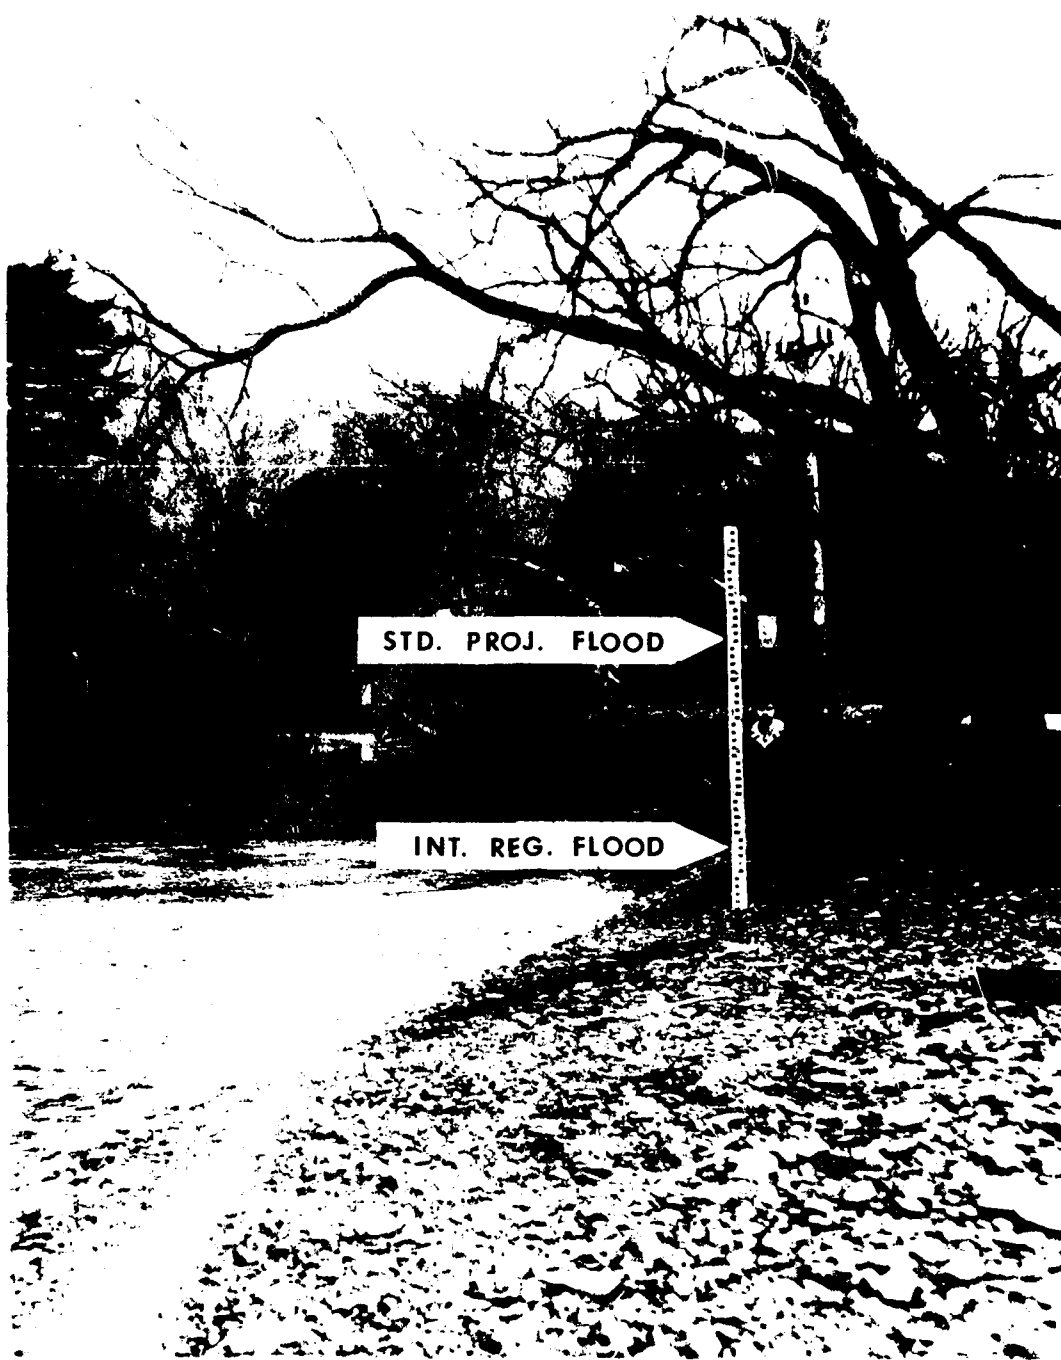
FIGURE 8 - Possible future flood heights near Sherwoods Bridge.

Photographs, future flood heights - The levels that the Intermediate Regional and Standard Project Floods are expected to reach at various locations in the Town and Village of Delhi are indicated on the following photographs.

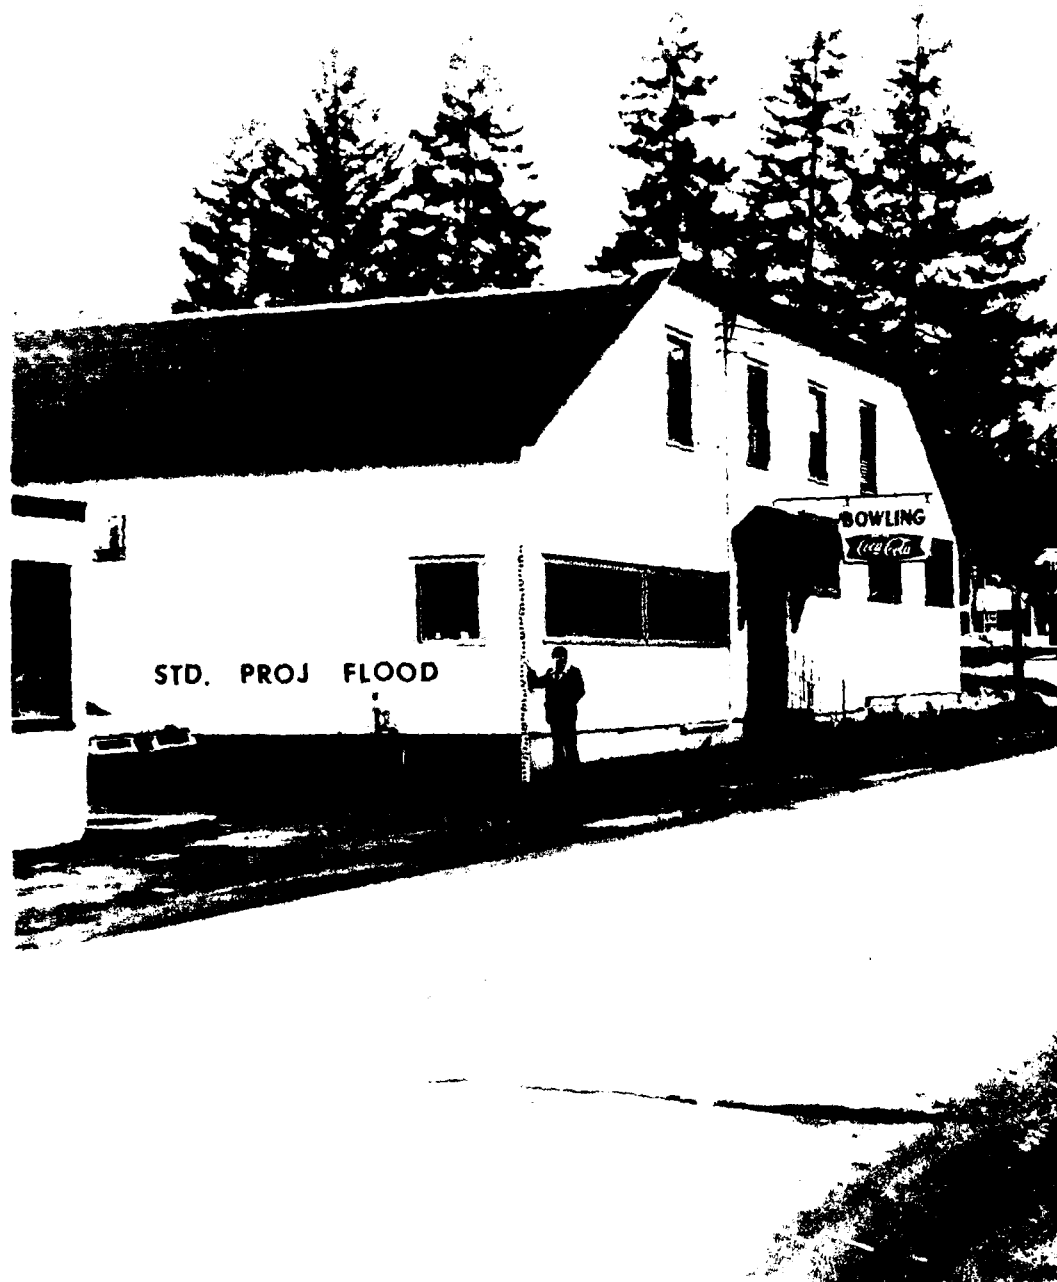
FIGURE 9 - Possible future flood height at the Bowling Alley on Kingston Street.

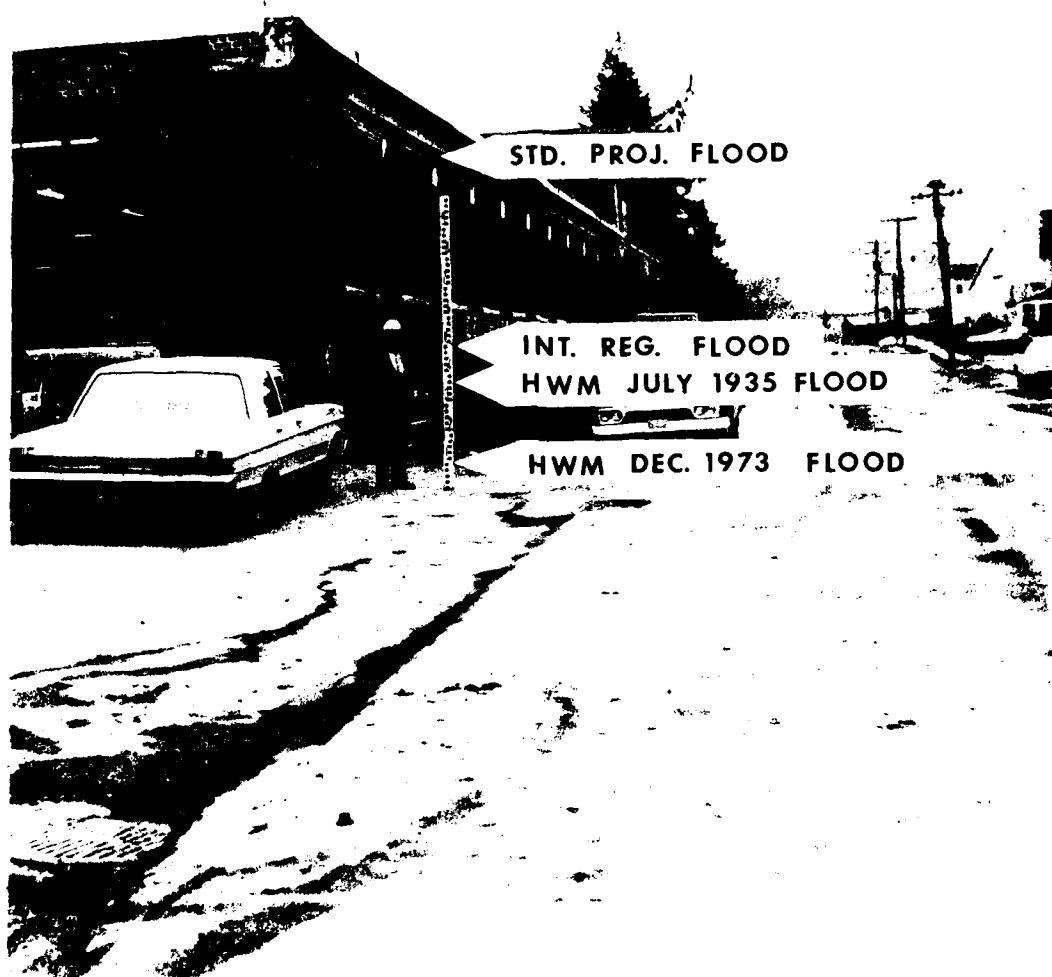
FIGURE 10 - Past and possible future flood heights at the Delaware County Highway Department.

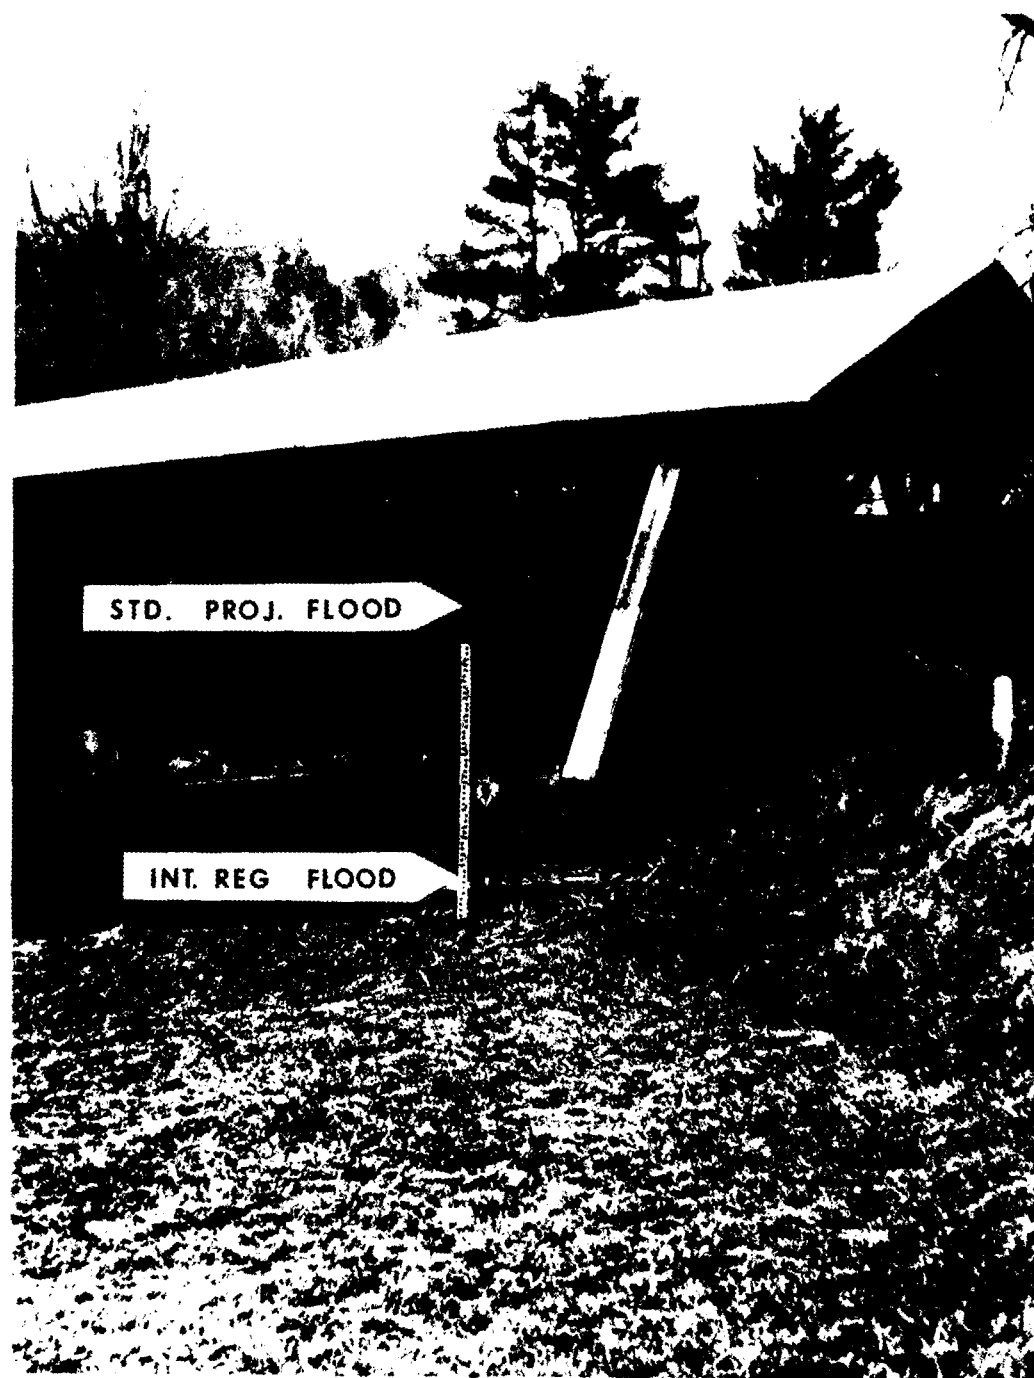
FIGURE 11 - Possible future flood heights at Fitches Bridge.
